Debris/Ice/TPS Assessment And Photographic Analysis For Shuttle Mission STS-38

February 1991

DEBRIS/ICE/TPS ASSESSMENT
AND
PHOTOGRAPHIC ANALYSIS
OF
SHUTTLE MISSION STS-38

November 15, 1990

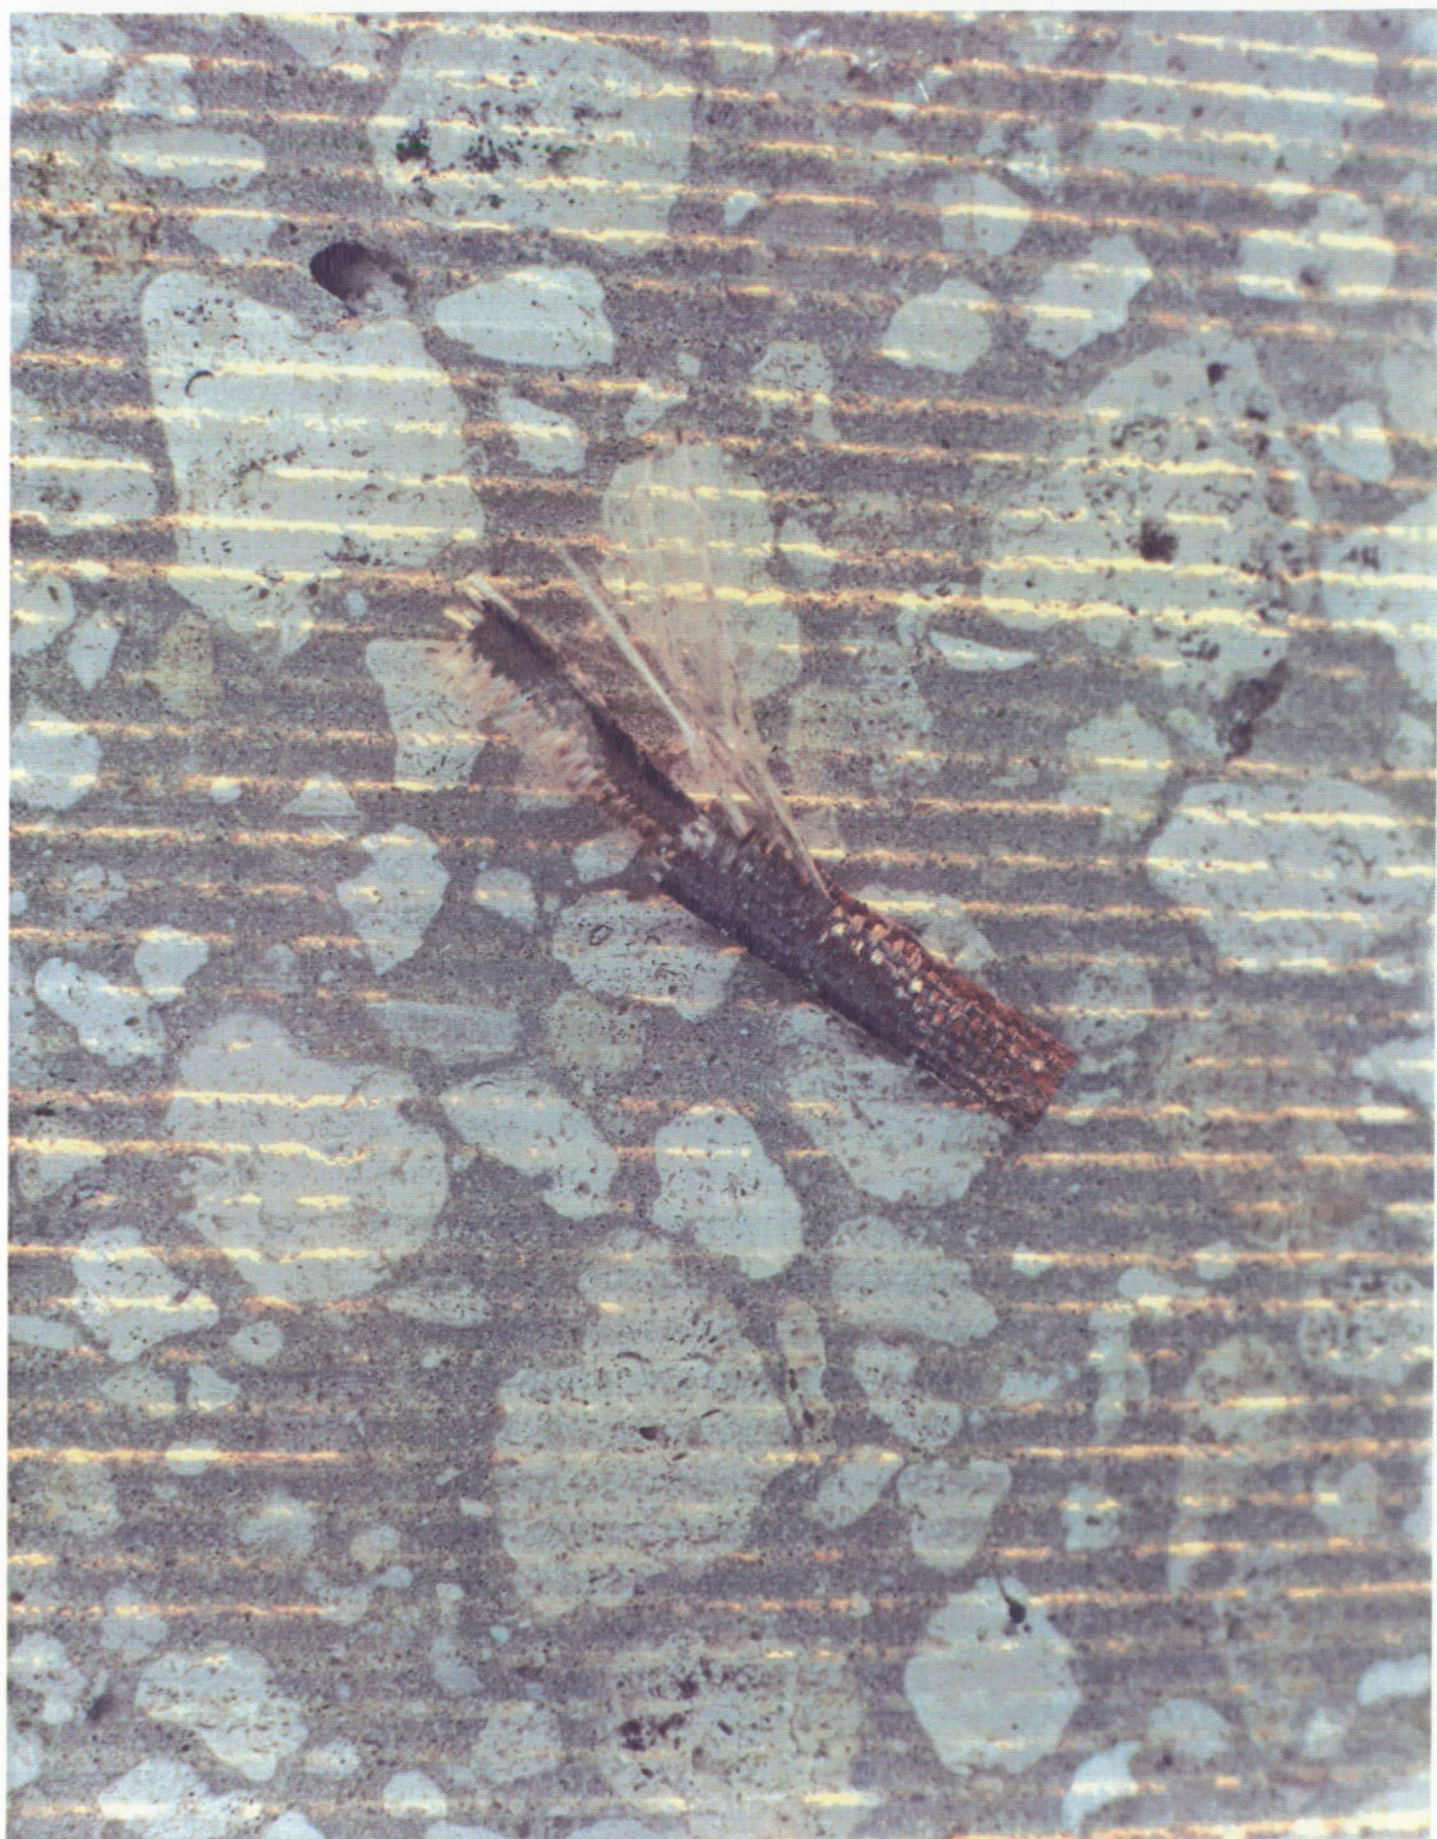
One 3" x 1/2" piece of Ames gap filler was found on the runway
50 yards south of Marker 14 near the runway threshold

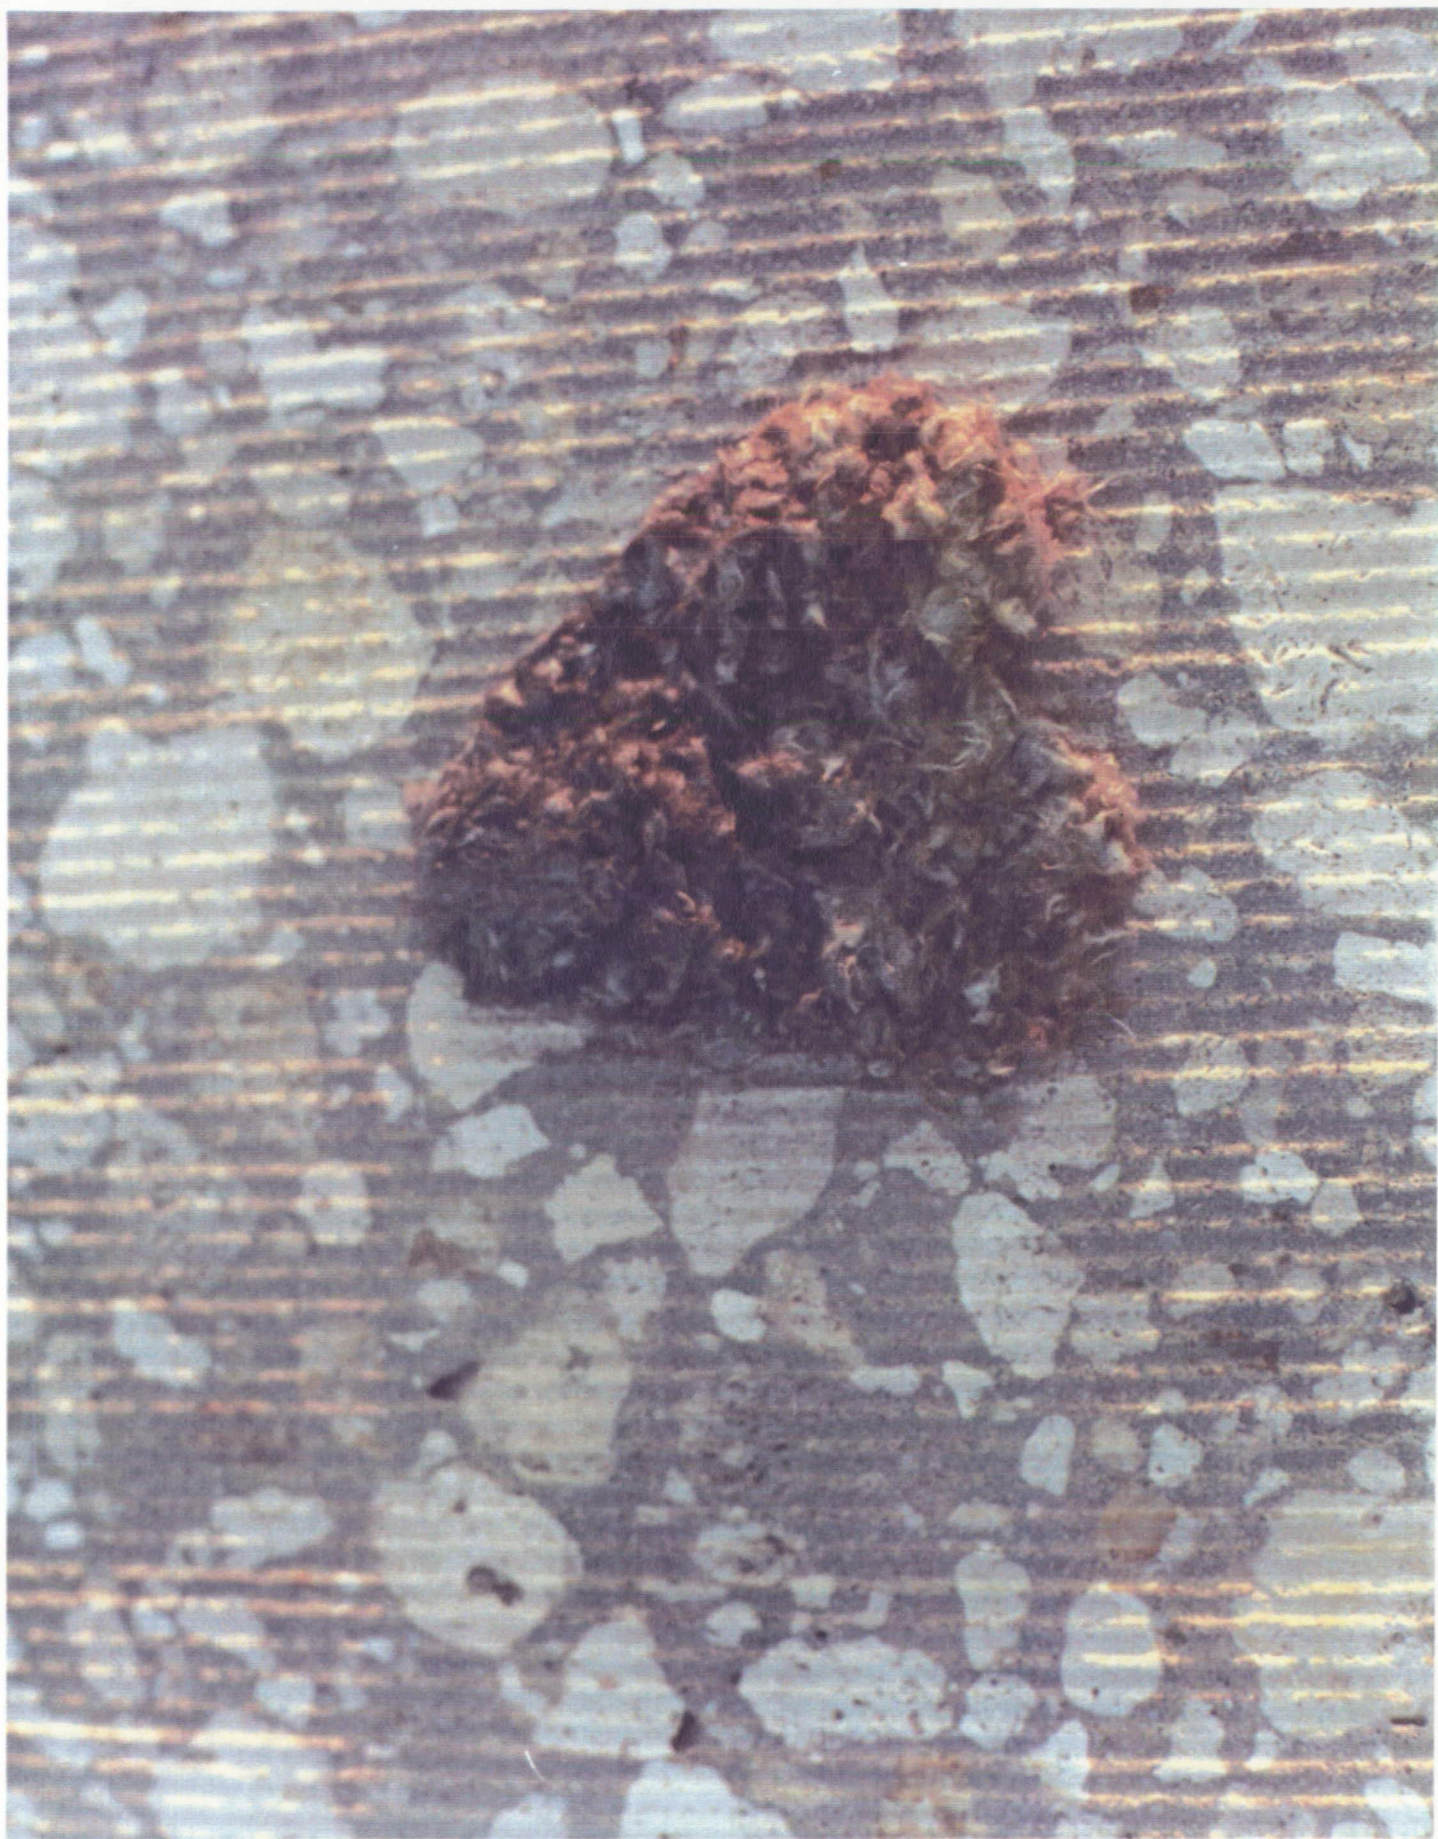
Four pieces of Cerachrome felt insulation from the SSME beta blankets were found on the runway near the threshold
